**SAS Superstructure**

Daily Diary Report by Bid Item

Contract No.: 04-0120F4

Diary #: 849 Const Calendar Day: 372 Date: 11-Jun-2013 Tuesday

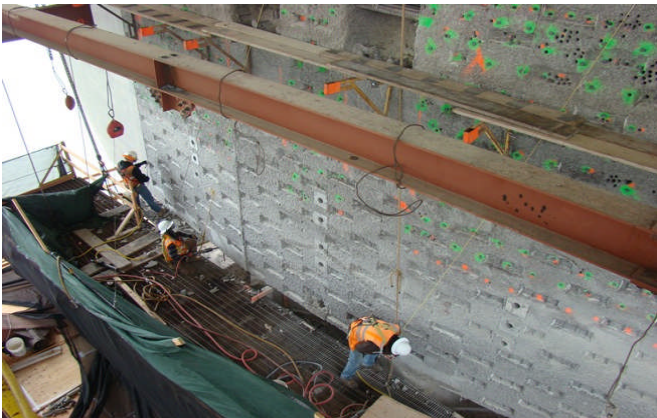
Conco laborers seen drilling and cleaning rebar dowel holes on the west face of the S1 (W-Line) Shear Key retrofit.

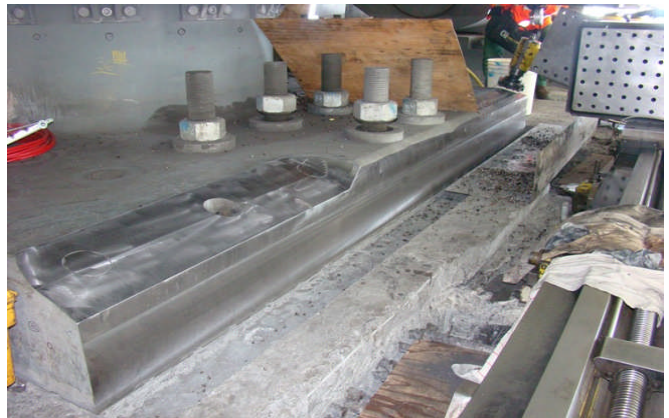
Beveled portions of the S1 Shear Key on the east side of the lower housing. This work is being performed by In Place Machining Company of WI.

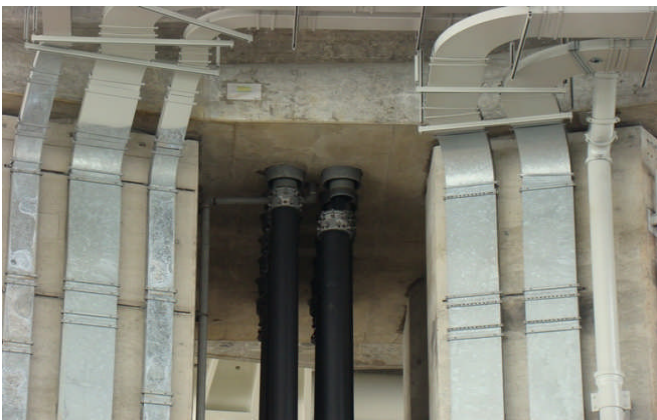
It should also be noted that I informed pertinent Caltrans personnel before leaving for vacation to repair the pipe sleeve connection for the Cable tie down HDPE protective pipes at the W2 cap beam. The friction connection has failed due to the daily thermal cycles of the bridge pushing the W2 cap beam west approximately more than 1inch during a sunny day. See photo below for more details.

Cable tie down HDPE protective pipe where the connection failed and has not yet been fixed since being found in May.

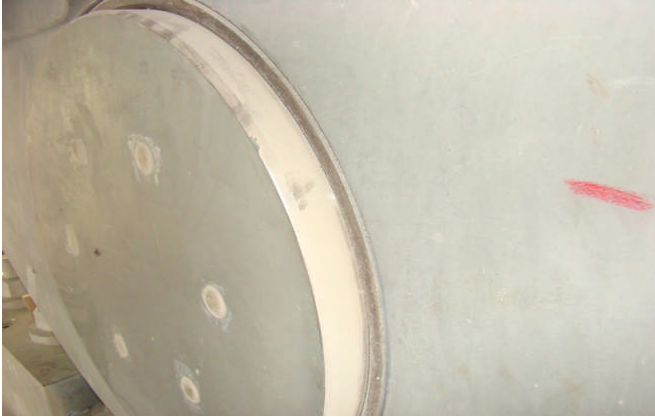
- 1.) Providing access to survey the drilled holes in the E2 cap beam for the S1/S2 Shear Key retrofit.
- 2.) Ensure that the concrete dust from chipping, bushing, drilling, and cleaning has not disturbed the pre-lubricated steel surfaces of the Bearings and Shear Keys. Prior to taking vacation I had to inform ABFJV engineer Eric Blue to inform the Conco foreman to put a protective barrier between the Upper and lower housings of the S1/S2 Shear keys to prevent dust from getting on the spherical component of lower housing stub. See photo below for more details and additional comments.

Concrete dust seen on the B2 Bearing pin north stub which needs to be cleaned to ensure free movement of the intended lubricated steel surface.
